LAKE ALEEDA DAM

NDI ID NO. PA-00557

PHASE I INSPECTION REPORT  
NATIONAL DAM INSPECTION PROGRAM

MAY 1979

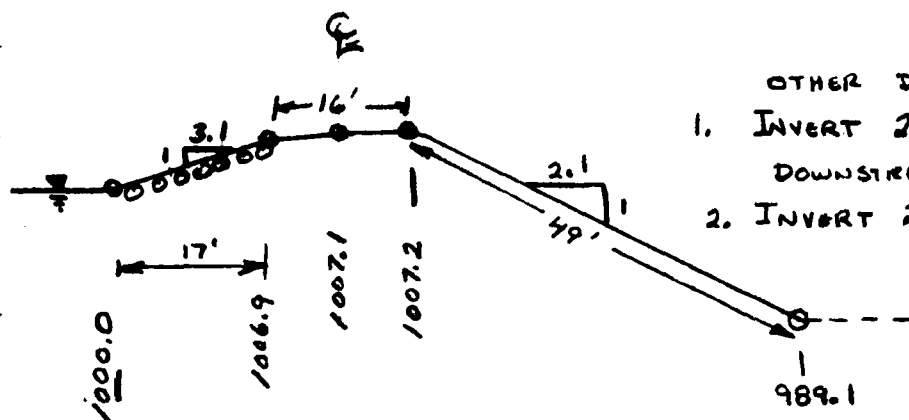
SECTION AT STA 5+33  
SCALE 1" = 20'

1. INVERT 2-72" CULVERTS  
DOWNSTREAM = 979.9
2. INVERT 24" CIP = 980.0

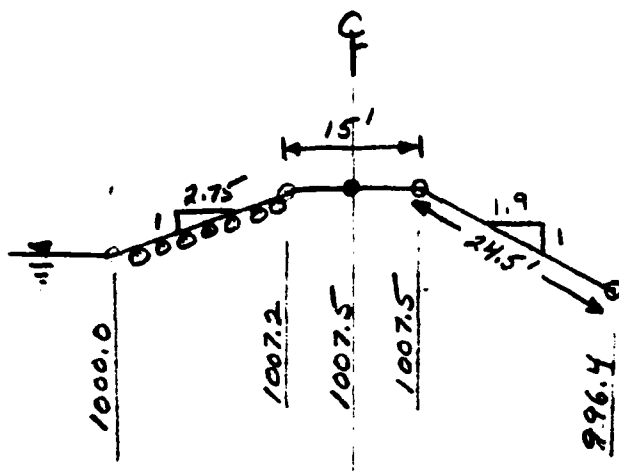
SECTION AT  
STA 3+50

NOTE: SURVEY DATA PRESENTED ON THIS PAGE AND ON THE PREVIOUS PAGE WAS ORIGINALLY ACQUIRED ASSUMING DATUM AT THE INVERT OF THE 24" RCP, EL 983.0. THE RESULTING ELEVATIONS WERE NOT CONSISTENT WITH THE DESIGN DRAWINGS. DATUM WAS THEN ADJUSTED TO EL 1000.0, THE DESIGN SPILLWAY CREST. THIS PLACES THE INVERT OF THE 24" RCP AT EL. 980.0
